| BOC Gases Site Services | | SAFETY SHARE | |
| Issue raised... | Hose tail Coiled under tension | Recommendations... | <p>I will remind customers if they are disconnecting cylinders they must leave all aspects of the cylinder, regulator and pipework in a safe condition.</p> |

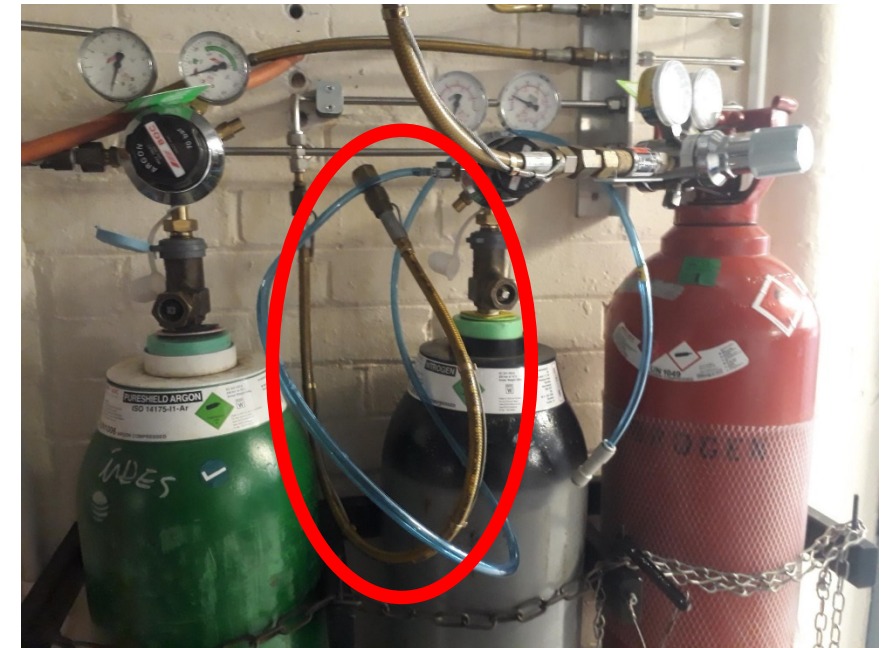
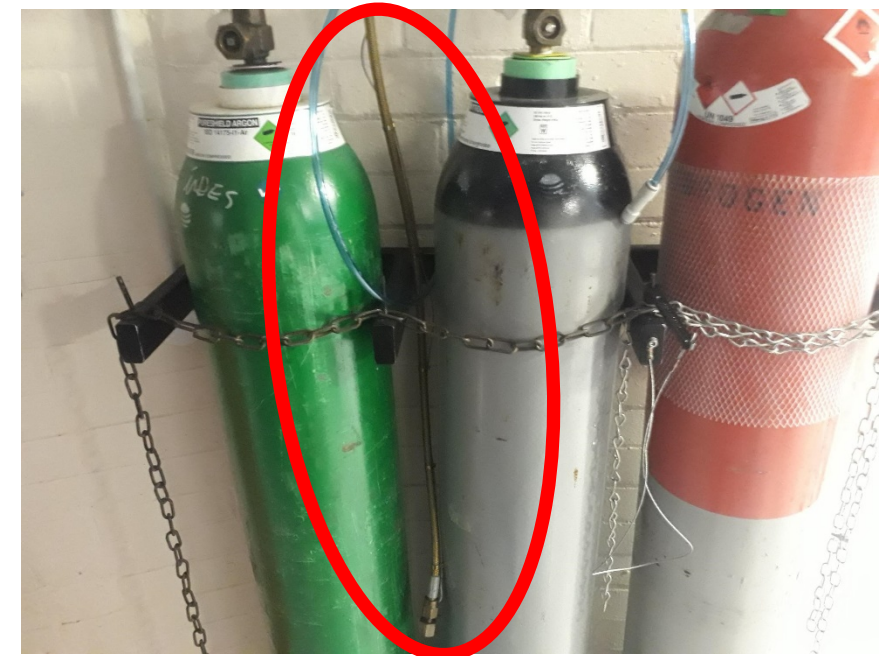
| BOC Gases Site Services | | SAFETY SHARE | |
|---|---|---|---|
| Further details... | <p>A disconnected hose tail was left coiled under strain against a cylinder in a walk way. There was a potential risk the hose tail could uncoil at speed whipping anyone walking past at head height. (see attached photos)</p> | | |

| BOC Gases Site Services | | SAFETY SHARE | |
|---|---|---|---|
| Date/Time... | 25-10-18 | Detail any actions taken... | <p>Safety share sent to H&amp;S Office 25-10-18</p> <p>I have uncoiled the hose and left it in a safe condition (see attached photos)</p> |
| <p>The Group Leader will raised this in the group meeting, to ensure that everyone knows that hose tails must not be coiled under tension.</p> | | | |
